NE 8th St

Walking Audits

Informed by our community

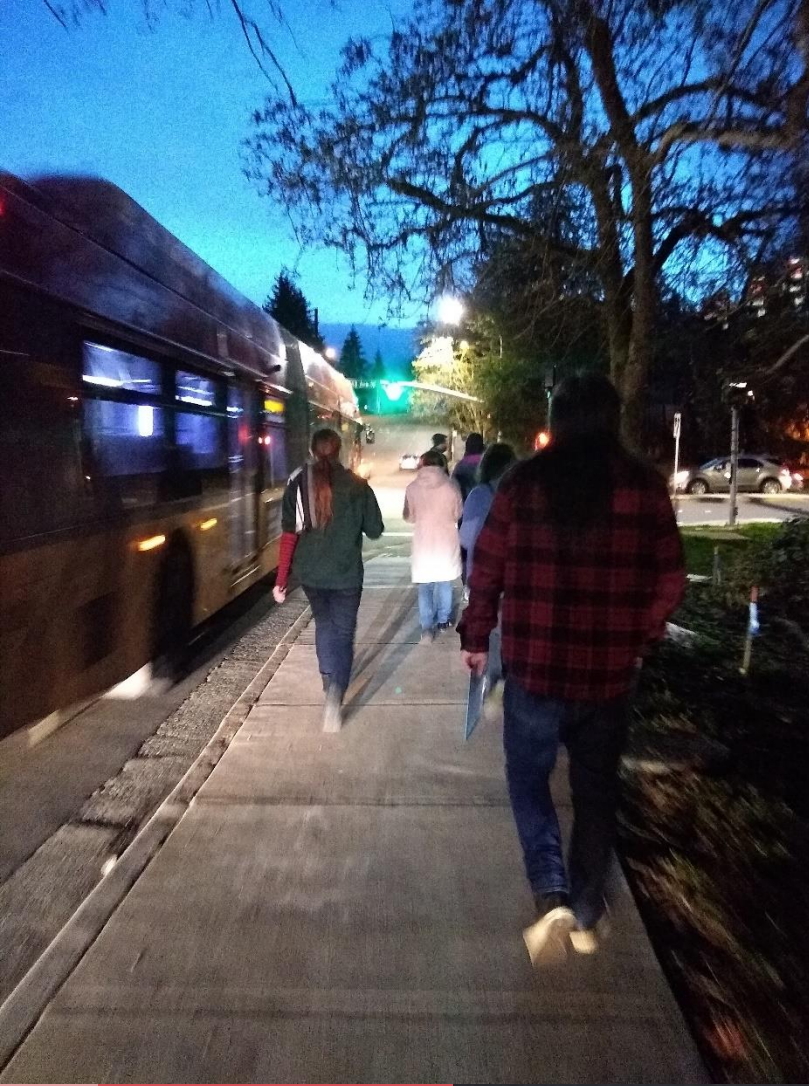
Previous, left: This sidewalk at the intersection of NE 8th St & 148th Ave NE is immediately adjacent to high-speed traffic.

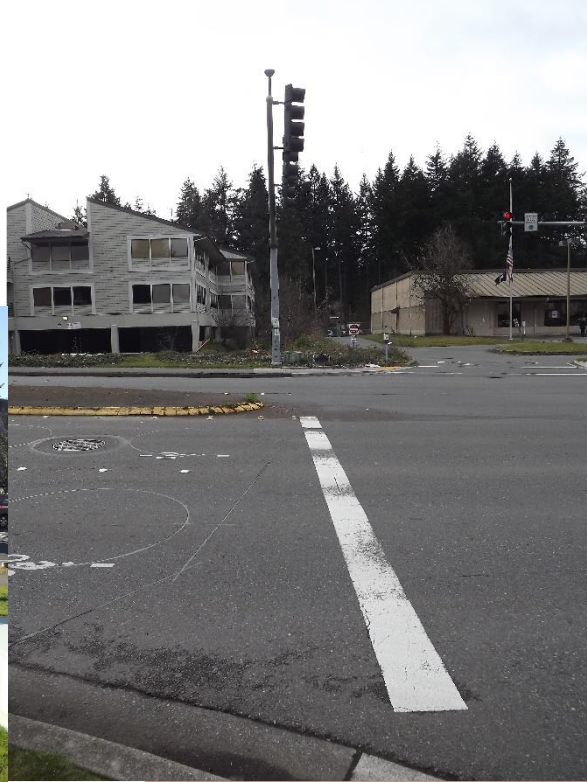
Below, right: Several intersections along NE 8th St, like this one at 158th Pl NE, do not have crosswalks on all sides.

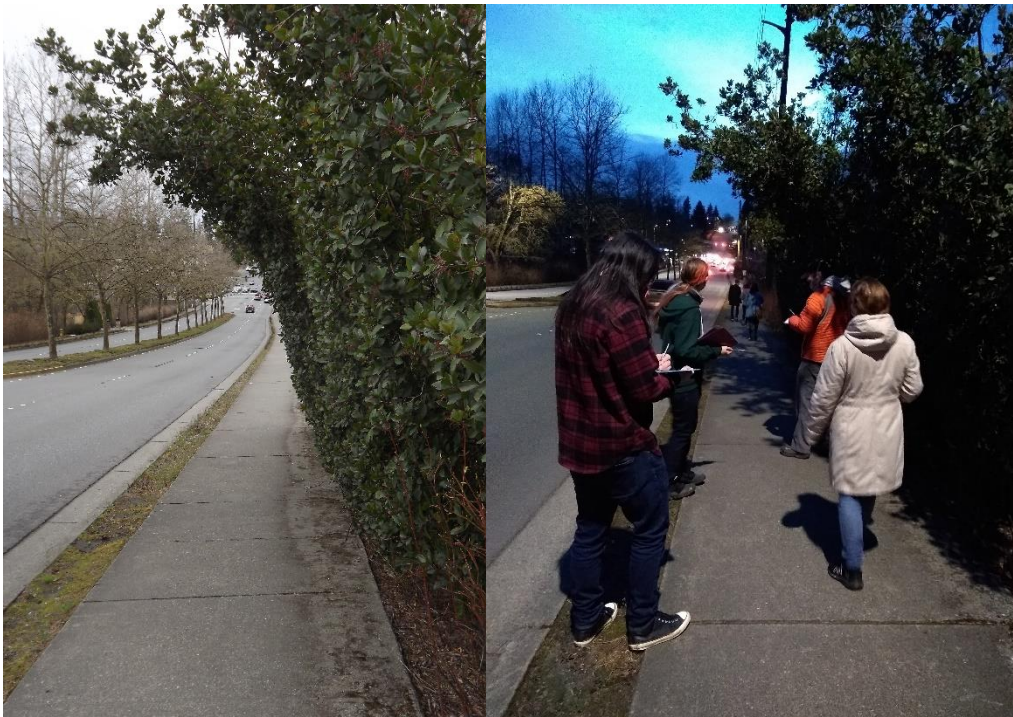
Far Left: Overgrown vegetation overhangs the sidewalk by approximately 2 feet and is at face-level for most adults. Low-vision pedestrians might run into these obstructions without seeing them.

the sidewalk. At another point west of 151st Pl NE, the tops of some cypress shrubs had grown such that portions above approximately five feet high were overhanging the sidewalk by two feet or more. Although both occurrences could be avoided by pedestrians moving to the other side of the sidewalk, these issues serve to reduce the effective width of the sidewalk, which can cause difficulties when multiple people are walking together. These issues could be solved through multiple methods, including 1) regular maintenance of vegetation to ensure it doesn't obstruct the sidewalk, and 2) choosing native vegetation that will require less maintenance and present fewer sharp edges that could injure pedestrians.

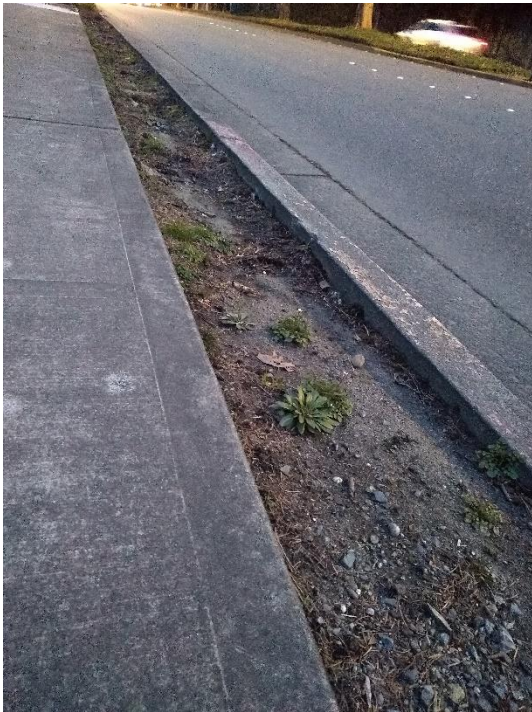
Left: Portions of the buffer between the sidewalk and the roadway were void of vegetation and soil, which created lips in the sidewalk that people could easily trip over. With cars frequently traveling in excess of 40 mph on this corridor, tripping into the roadway would be a dangerous safety hazard.

disappearing as our group approached 148th Ave NE. Although the lack of a buffer near 148th Ave enables a wider sidewalk, it leaves pedestrians immediately beside cars that are often reaching their highest speeds as they reach the bottom of a large hill. If larger vehicles have objects that extend slightly beyond the roadway (e.g. mirrors from trucks or buses), it's possible that pedestrians walking with traffic could be hit without seeing any danger coming. Additionally, our group saw how vegetative buffers really only provide protection if they are filled with vegetation; in several sections where the buffer was only one foot wide, there was no vegetation present and/or soil had been stripped away from the area, creating an uneven surface with the rest of the sidewalk. This uneven surface presents a legitimate stumbling hazard for pedestrians, who at best might end up with scraped hands and at worst could fall into high-speed traffic. Regular maintenance of these buffers, planting & maintaining native vegetation that provides actual protection for pedestrians, and (if possible) widening these buffers to increase the distance between pedestrians and vehicular traffic would all work to improve safety.

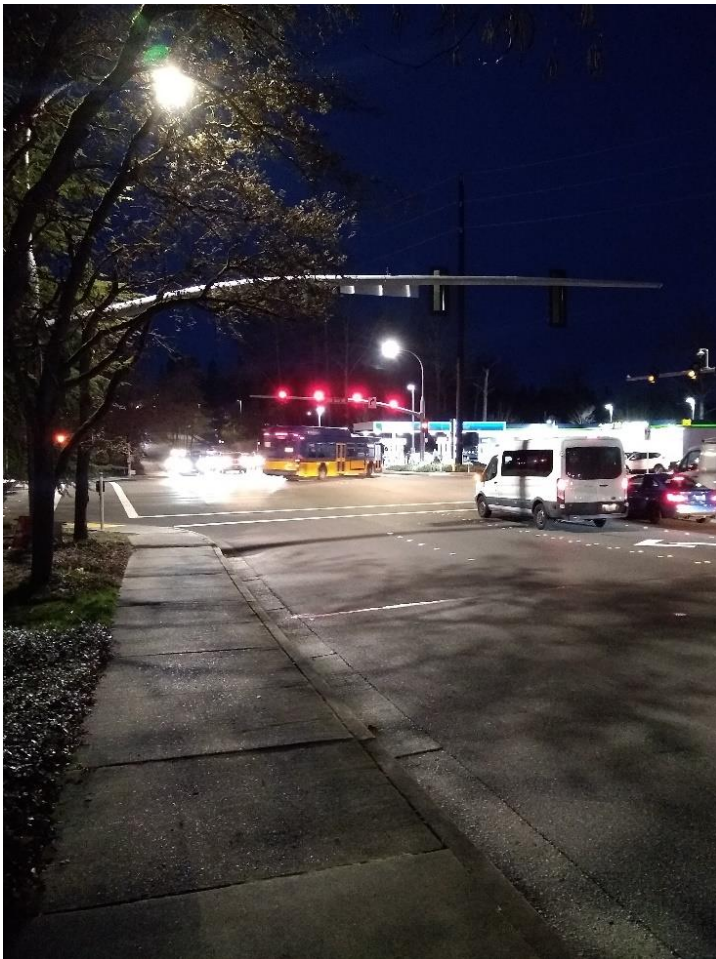
Left: The intersection of NE 8th St & 148th Ave NE as viewed from the NW bus stop. Each side of this intersection is several lanes wide, which increases crossing time for pedestrians.

crossing the multiple lanes of 148th Ave NE illustrated to our group how, once pedestrians are given the walk signal, we are not given enough time to cross comfortably or safely - all of our group was still tens of feet from the opposite sidewalk when the signal count reached zero. Although this intersection does see significant vehicle traffic, this should not negate the importance of or overly inconvenience the several pedestrians we saw along our walk who were traveling in all directions. This intersection has several establishments, including reproductive healthcare, a supplement store, a podiatrist, and many others, that can provide important healthcare services to local residents - readjusting signal and crosswalk timing to be more comfortable and accommodating for people of all mobility levels should therefore be a priority for improvements to this corridor.

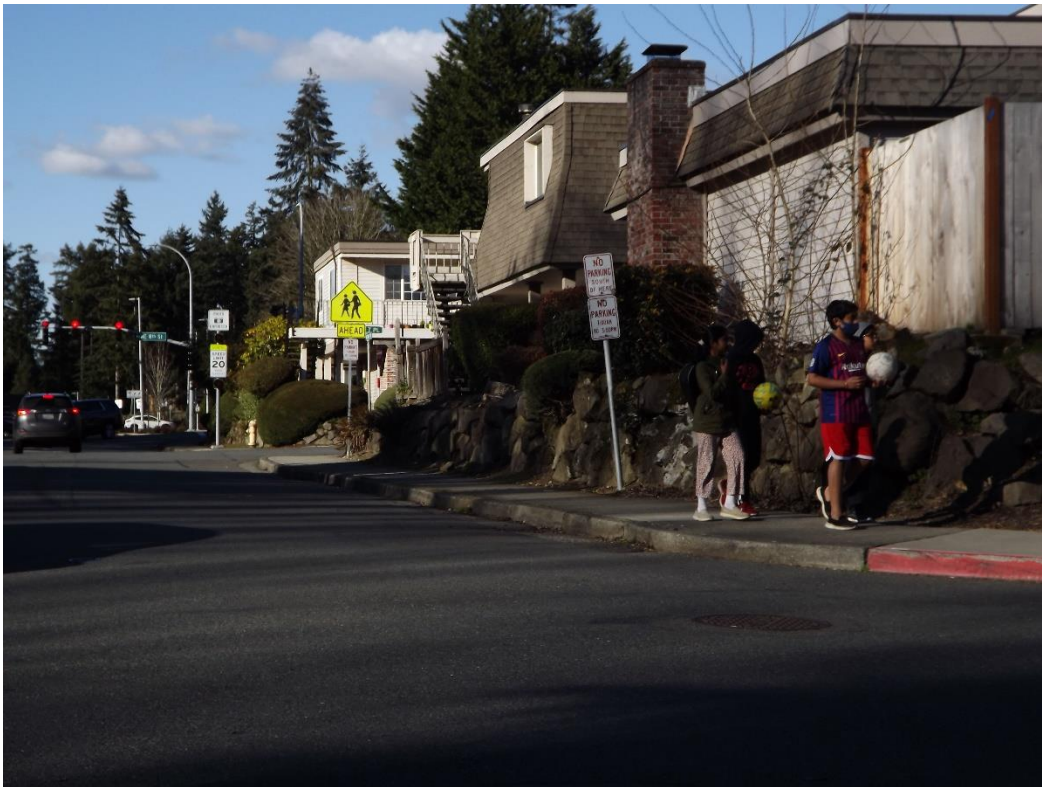
Left: Children approach the unsignalized intersection near Odle Middle School. Although outside the study area, Bellevue must incorporate walkability assessments and concerns into all planning decisions.

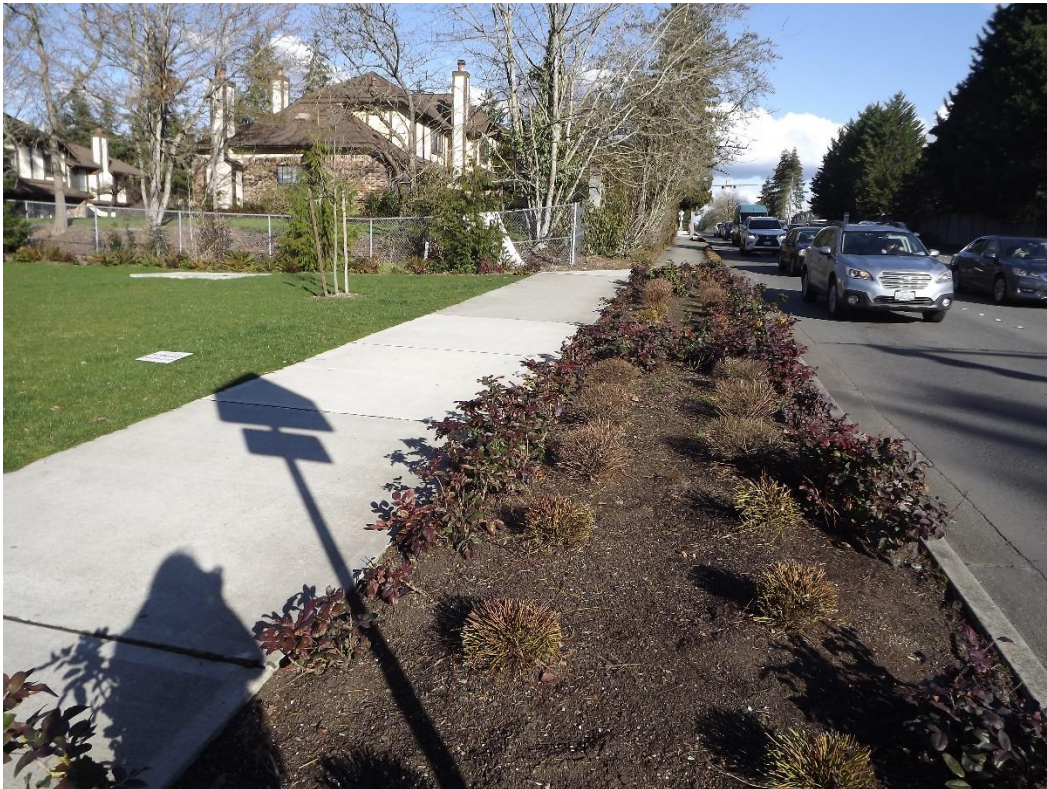
Left: The vegetative buffer in front of Stevenson Elementary School was several feet wide, providing substantial protection from automobile traffic. Our group would have felt safer if this level of protection was present on the entire corridor.

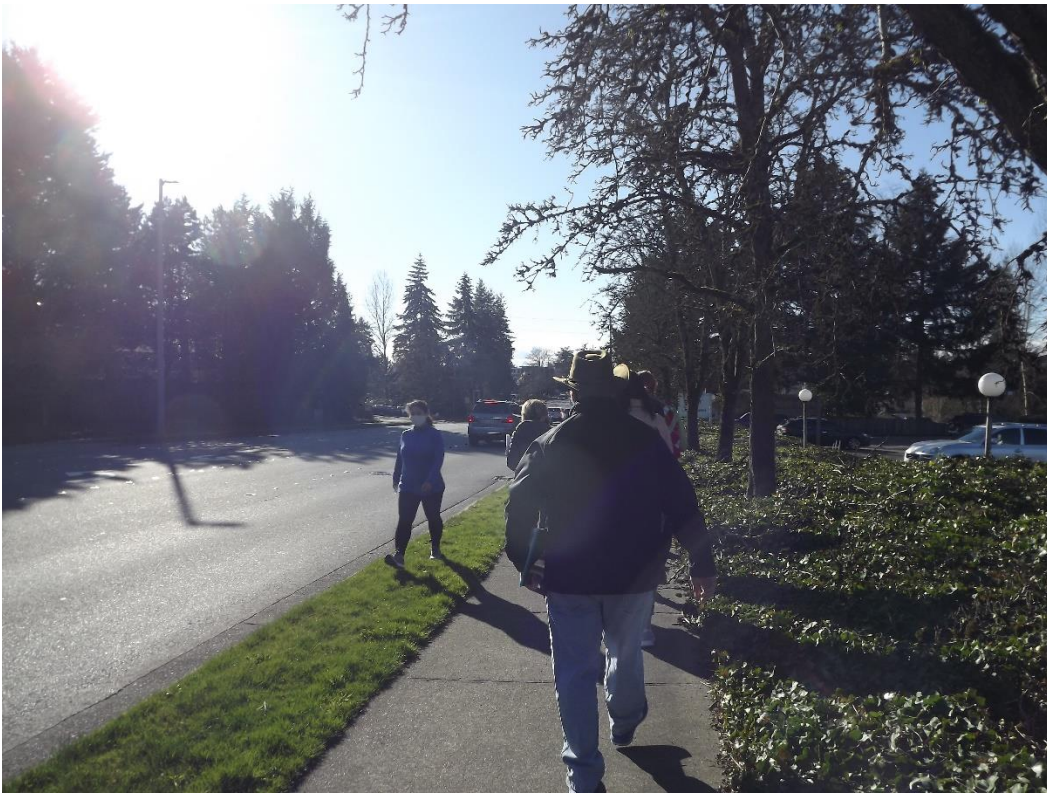
Left: A pedestrian enters the grass to pass our group as we walk westwards towards 140th Ave NE. Wider sidewalks would provide safe distances for pedestrians to pass each other, especially because of COVID-19 concerns.

the property line on to the Montessori School to the west, the sidewalk & vegetative buffer both narrowed to levels that were uncomfortable for our group and passersby. Additionally, our group noted how visitors walking or rolling to either the Montessori School or the Asia Pacific Language School do not have a dedicated sidewalk - students would need to walk along the driveways and through parking spaces to access the front door. Although our group recognized that the latter two schools were private institutions (in contrast to Stevenson Elementary, a public school) and how there might be different regulations around walkability as a result, we wondered whether it would be possible to incentivize or require private property owners to factor walkability in their site designs.

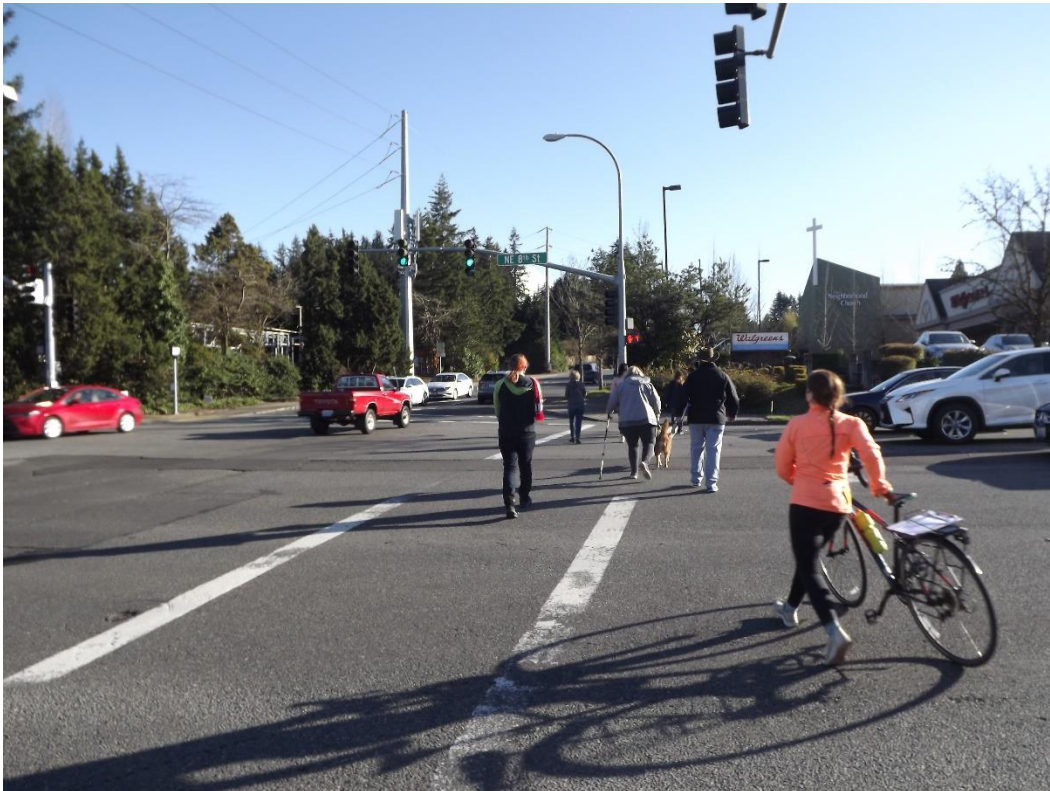
Left: Most of our group was still tens of feet removed from the other side of the crosswalk when the timer reached zero. Because this intersection is used by families, seniors, and people of different mobility levels, these crosswalk times should be lengthened to safely accommodate more people.

pedestrian presence would be possible. For example, similar to other intersections in Bellevue, if a pedestrian does not press the beg button within the first few seconds of the traffic cycle, they will often be made to wait until the next cycle - even if there would have been enough time for the pedestrian to cross. Retooling the cycle time to more flexibly accommodate people crossing would go a long way to improving the experience for pedestrians on this well-traversed corridor.

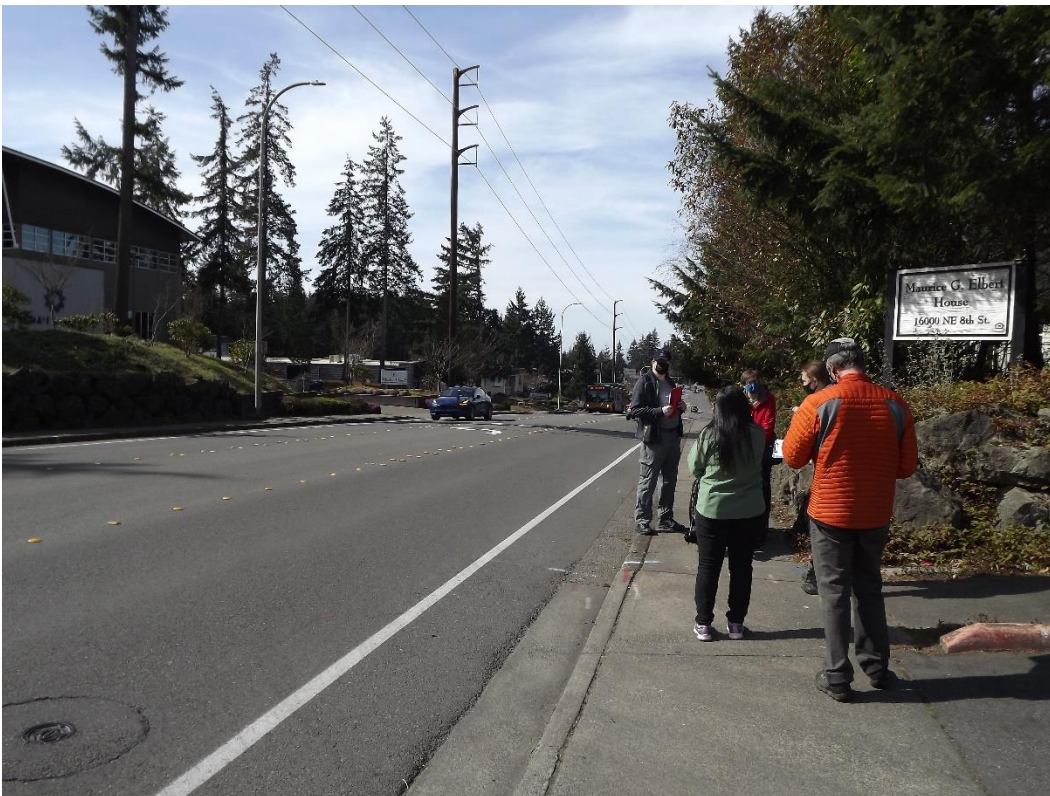
Left: Our group stops at the site of a pedestrian fatality in November 2020 and reflects on the road design elements that contributed to this collision. The nearest marked & signalized crosswalks were several hundred feet away – an added distance that can be inaccessible for mobility-challenged residents.

gentleman was walking home and had nearly crossed the street when a driver collided with him. Members of our group noted how the nearest marked crosswalk was several hundred feet away from the collision location. The 16000 block of NE 8th St contains the Maurice G. Elbert House, a senior living facility that the gentleman was likely trying to access. Navigating to a marked crosswalk would've added an additional 1000 feet to his journey, which can be prohibitive for somebody with low mobility. Several members of the group expressed how they themselves would feel comfortable crossing at this intersection because of the high visibility to vehicles in both directions. All participants agreed that, for the number of businesses and establishments located on this portion of the corridor, there should be more marked and/or signalized crosswalks for pedestrians to use.

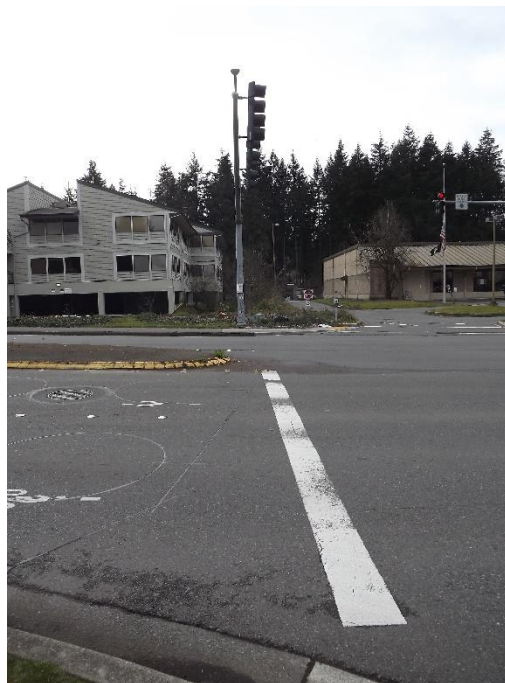
Left: The eastern side of the intersection of NE 8th & 158th Pl NE is currently lacking a crosswalk. If people approaching from the east need to cross and then double back slightly to reach their destination, this adds time & distance to their trip.

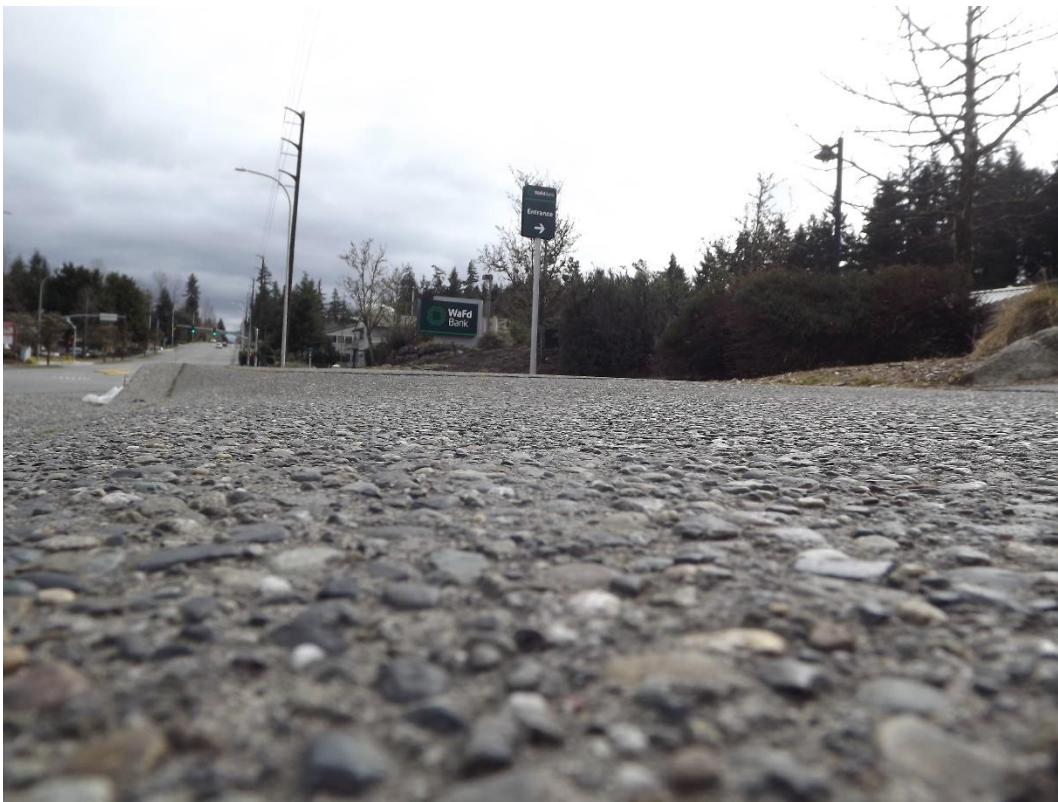
Left: Nearly every driveway along this section of the corridor has a corresponding bump in the sidewalk that was most pronounced closest to the roadway but decreased as one moved away. This added bump has the consequence of making half of the sidewalk less accessible for people who are biking or rolling.

Once on the south side of NE 8th St, our group continued westwards toward 156th Ave NE, passing by several businesses and their respective driveways. One issue that became apparent very quickly is how at each business's driveway, a sharp incline was created at each intersection of the crosswalk - that is to say, portions of the sidewalk close to the roadway would dip sharply down at each driveway, and then rise sharply back up on the opposite side. This effect was less pronounced on portions of the sidewalk further away from the roadway, but this essentially reduced the effective width of the sidewalk to less than half, since the inclines would either be uncomfortable or insurmountable for people in wheelchairs. These bumps also impact bicycle riders (of which our group saw several) who are forced to ride on the sidewalk due to the lack of protected facilities on the roadway. In addition to the dangers arising from conflicts with pedestrians, these bumps are easily missed and can be dangerous when approached at high speeds, especially since this portion of the sidewalk is narrow and immediately adjacent to the roadway with no vegetative buffer. One group member noted sidewalk designs in the Netherlands and how intersections with driveways would keep the sidewalk level, rather than lowering the

sidewalk to the level of the roadway. Using this approach at these driveways would create a natural calming effect for drivers while reducing accessibility issues for people walking, biking, and rolling.

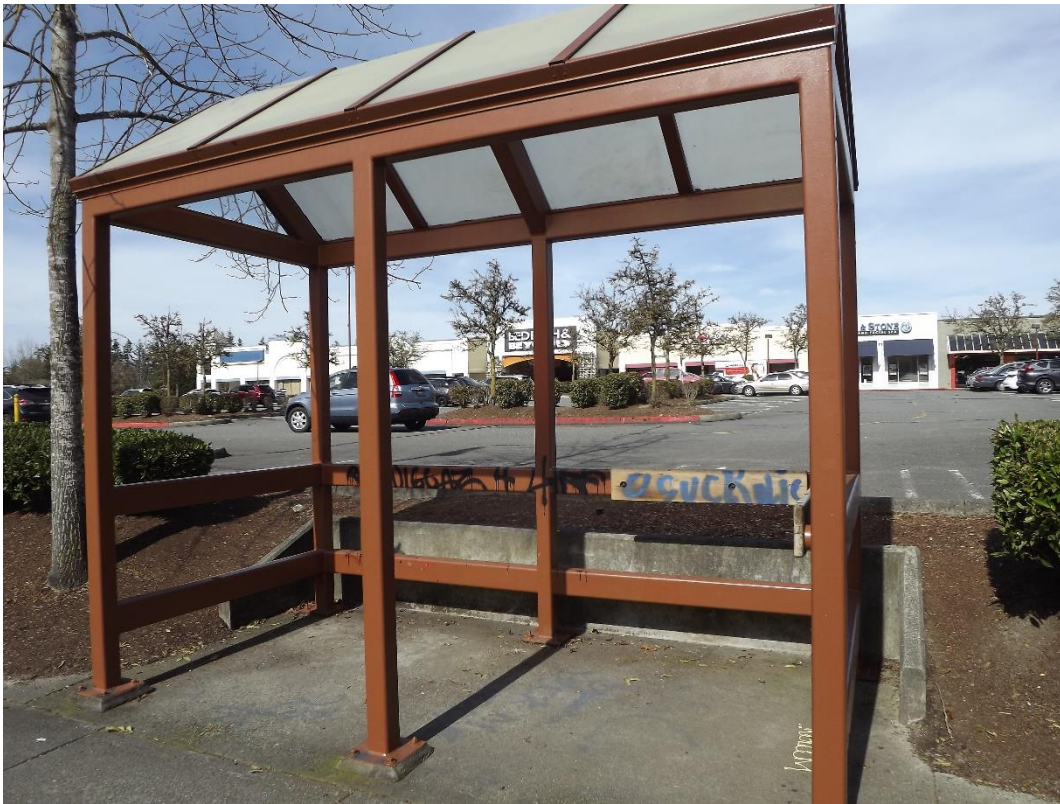
Left: This bus shelter at the NW corner of NE 8th St & 158th Pl NE had no walls to protect patrons from the wind, is heavily graffitied, and does not include a bench. Although likely not under Bellevue's jurisdiction, improving this bus shelter would greatly better the transit experience for riders who regularly use this stop.

After our group crossed to the north side of NE 8th St, we noted that the pedestrian experience became much safer and more comfortable. This side of the street had a sidewalk which was divided from the road by a vegetative buffer with tall trees that provided true separation from high-speed traffic. This side of the roadway also did not contain as many driveways, and the one that was present was substantially more accessible for wheelchair users. However, at the northwest corner of the intersection of NE 8th St & 158th Pl NE, there is a dilapidated bus shelter that contains no benches and is very poorly maintained. This bus stop is served by the 221 and provides good access to Crossroads Mall, so restoring this shelter to good condition and adding a bench or other seating

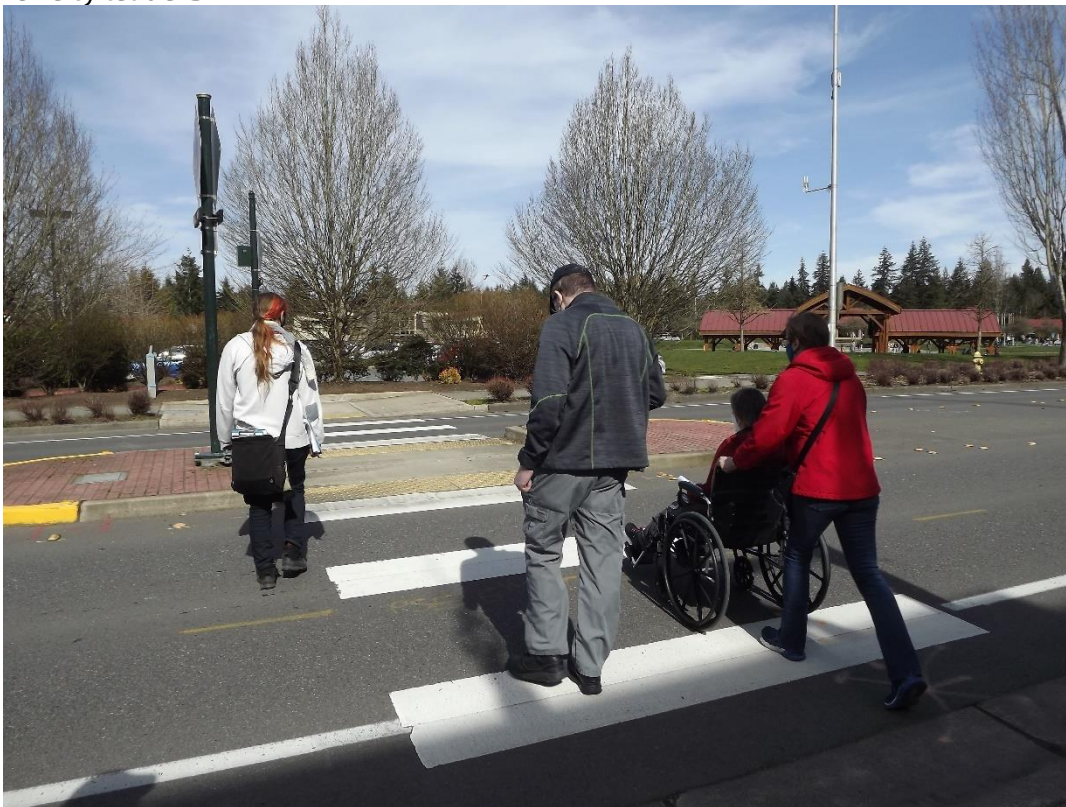
Left: Our group crosses a marked & signalized crosswalk in front of Crossroads Park. For the number of businesses & residences on this corridor, more crosswalks like these should be added to improve pedestrian safety.
